## The Crash of the Pusher in Cambodia - Tail #66-19114

By [Clifford J. Morley](#)

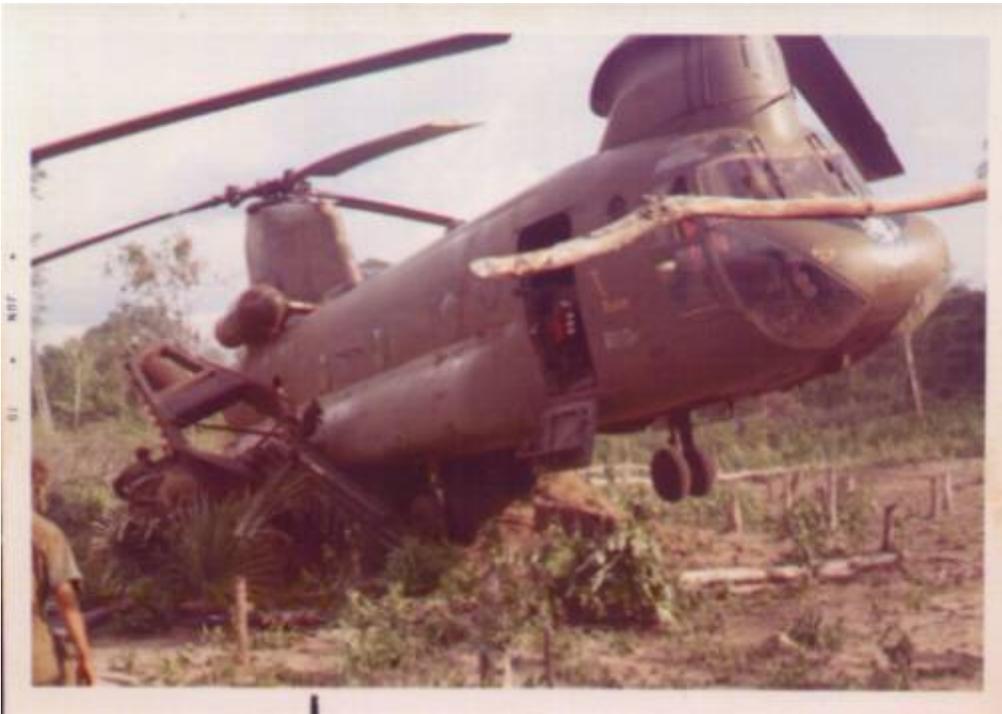
Photo 3: The 105mm Howitzer protruding from the right fuel pod.

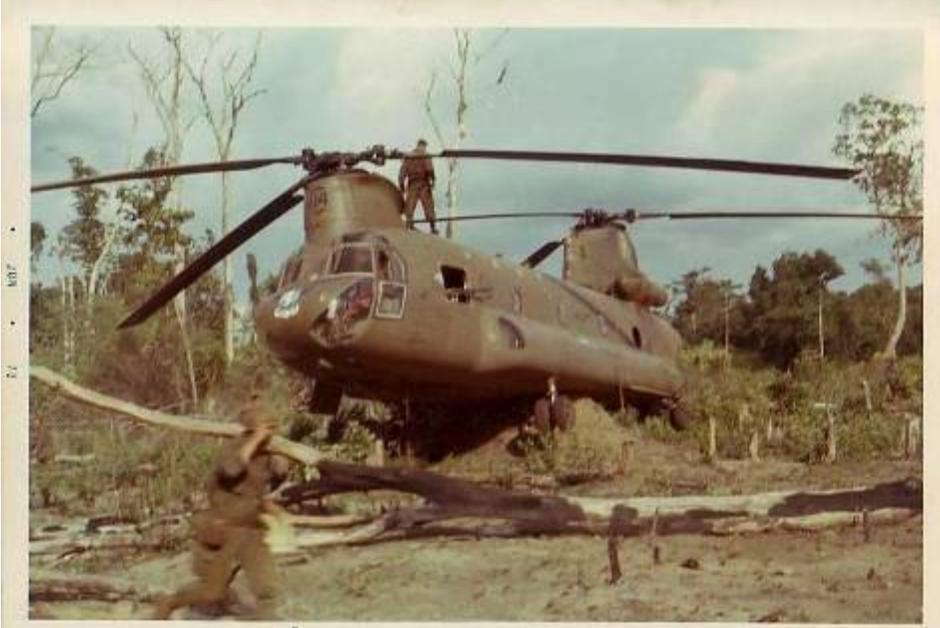
The aircraft commander, Capt. Larry D. Mohler, is on top of CH47B 66-19114 making a final inspection before flying the damaged aircraft, alone, off to the side of the LZ. Army Accident Report #700504321 says our approach to the LZ was from south to northwest so my conclusion is that 114's nose is pointing in a general northwesterly direction.
